*Technical Report No. 32-941*

*Experimental Assembly and Sterilization  
Laboratory (EASL) Operations: Phase I*

JET PROPULSION LABORATORY  
CALIFORNIA INSTITUTE OF TECHNOLOGY  
PASADENA, CALIFORNIA

April 15, 1966

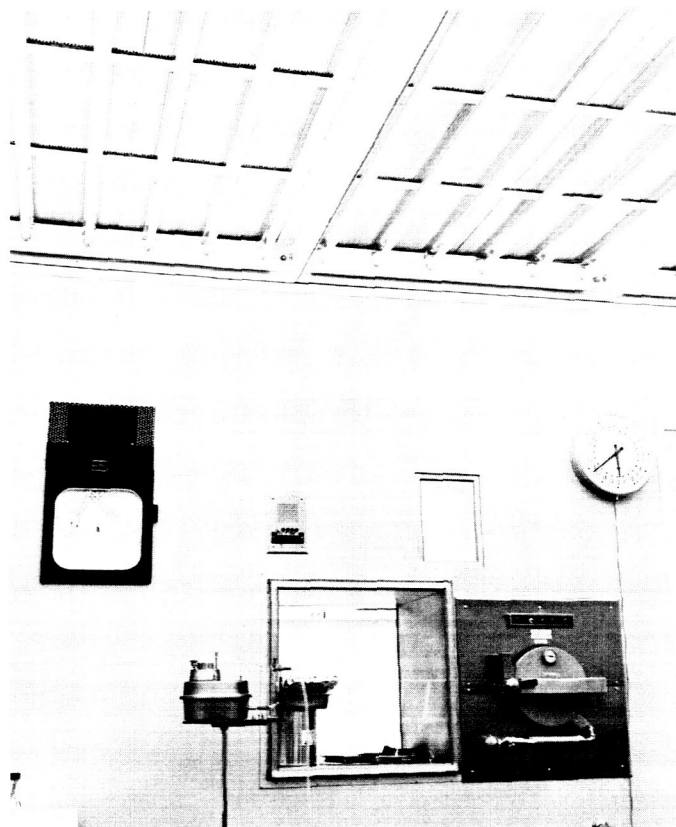
Fig. 2A. Laminar-flow room; view toward ceiling

The assembly room is isolated from the "clean" side of the dressing room by an airlock with a 0.10-in. wg positive-pressure differential, and utilizes the laminar downflow air principle. The bio-assay room opens off the assembly room and utilizes the same laminar downflow system; it is isolated from the Operational Support Equipment (OSE) area by maintaining an 0.25-in. wg pressure differential and an airlock. The OSE and receiving, cleaning, and decontamination room provides pass-throughs to the dressing, assembly, and bio-assay rooms (Fig. 2) and includes a laminar crossflow workbench; it is isolated

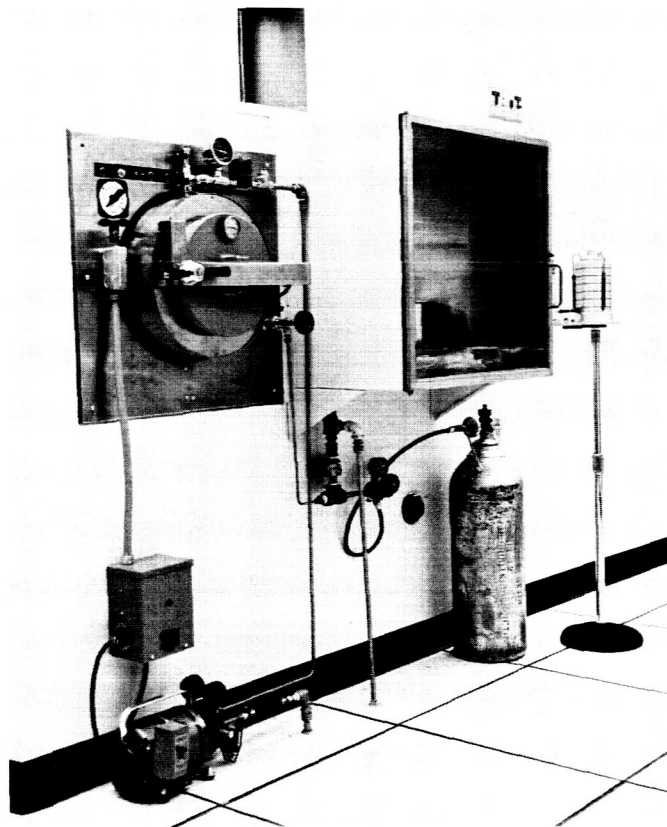
Fig. 2B. ETO pass clave and pass through OSE area

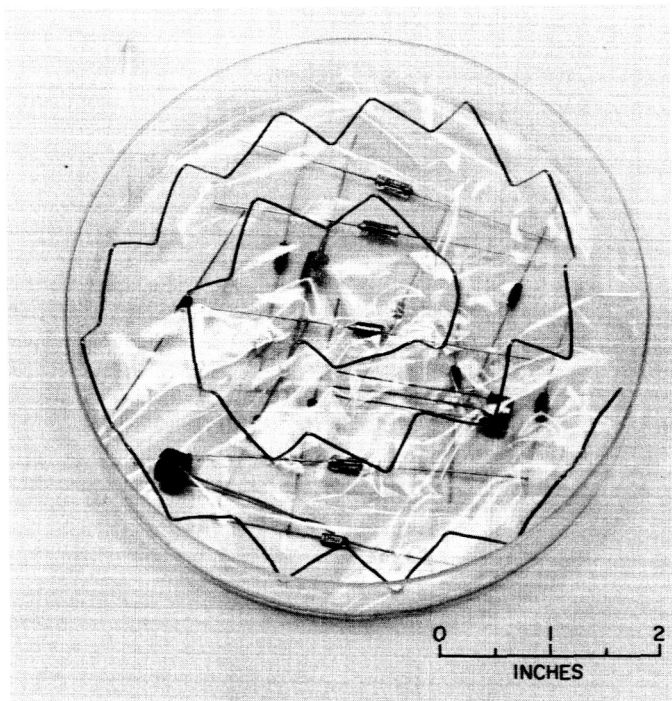
**Fig. 3A. Packaging of components for ETO decontamination**

For example, electronic components and certain tools were given ETO decontamination (Fig. 3); bagged clothing and mylar printed drawings were wiped with amphyl;

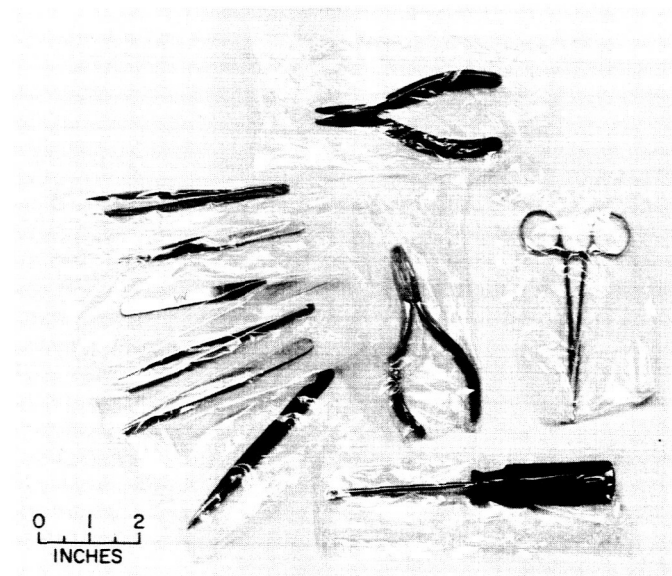
**Fig. 3B. Packaging of tools for ETO decontamination**

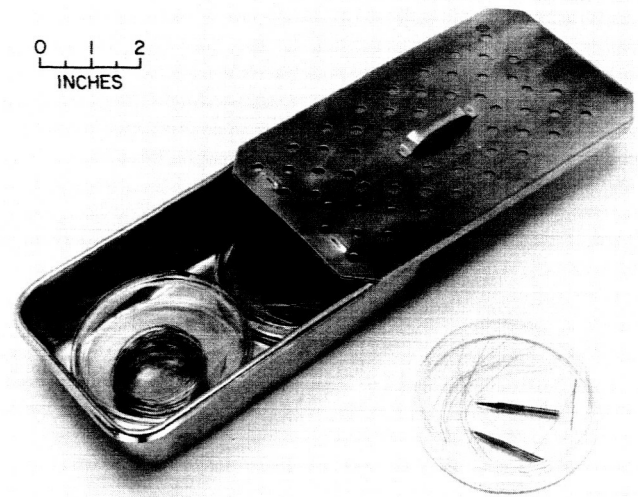
**Fig. 4. Packaging of metal components for heat sterilization**

and metal parts and other tools were heat sterilized (Fig. 4).

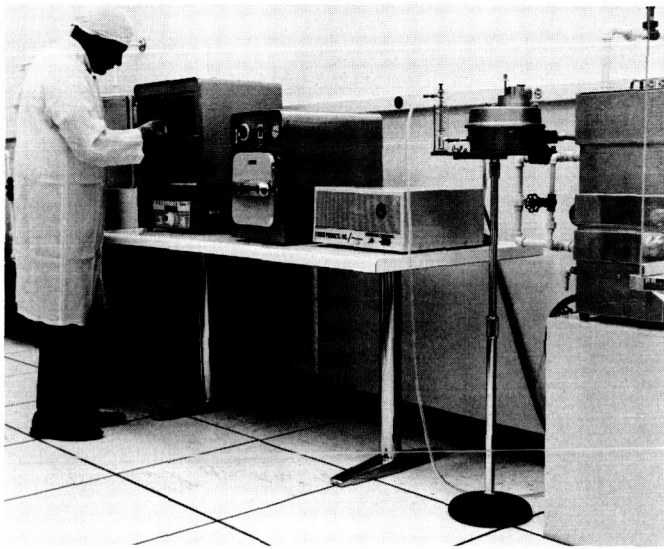
**Fig. 5A. Sterilization equipment; OSE area**

These operations were conducted in the OSE receiving and decontamination area (Fig. 5) and, where necessary, in the JPL microbiological laboratory.

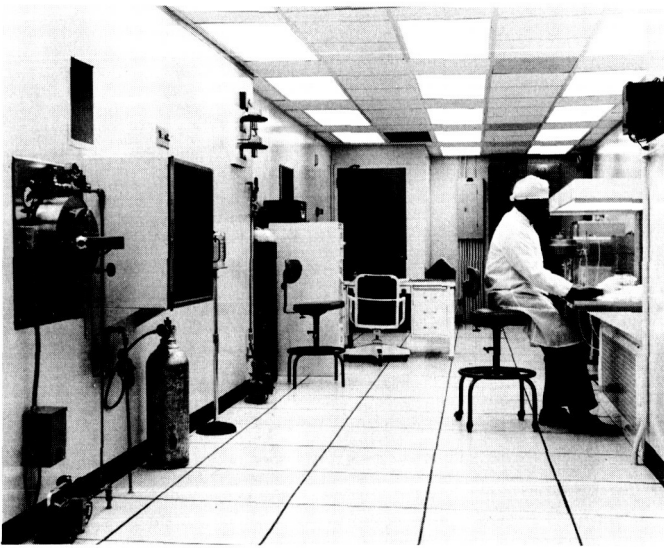
**Fig. 5B. OSE area; view toward entrance**

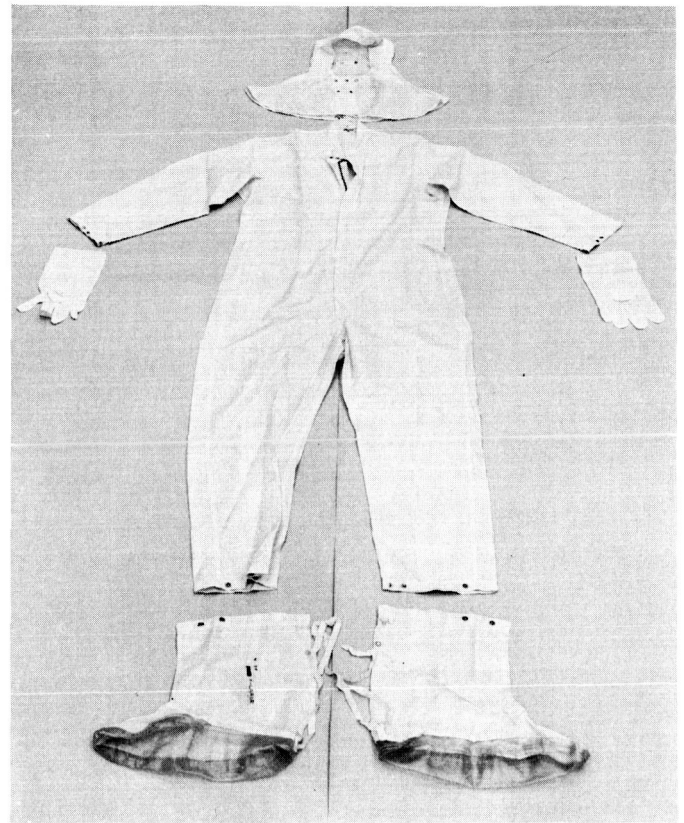
**Fig. 6. EASL garments**

The clothing worn by the persons within the laminar downflow room consisted of ETO-treated dacron hood, coverall, and boots (Fig. 6). In addition, a sterilized surgeon's mask was worn by each person entering the laminar downflow room.

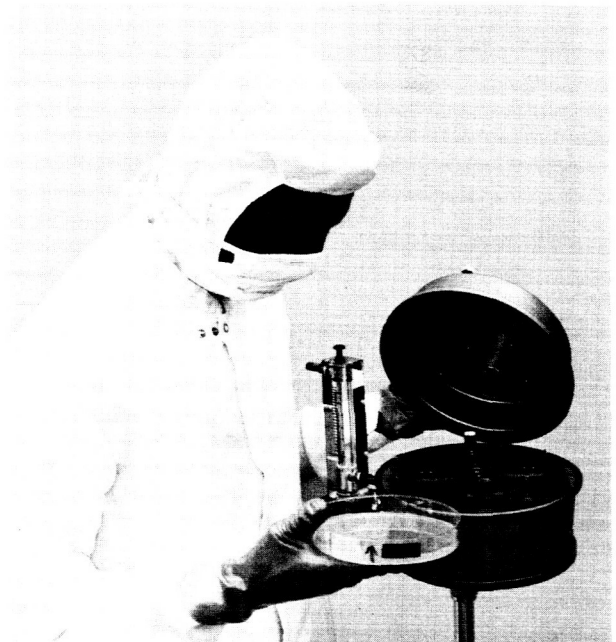
Fig. 7. Air-sampling apparatus

Volumetric air samples were collected with a Reyniers slit sampler (Fig. 7). Each sampler was calibrated to operate at an air-sampling velocity of 1 ft<sup>3</sup>/min. Trypticase Soy agar was used for all volumetric air sampling.

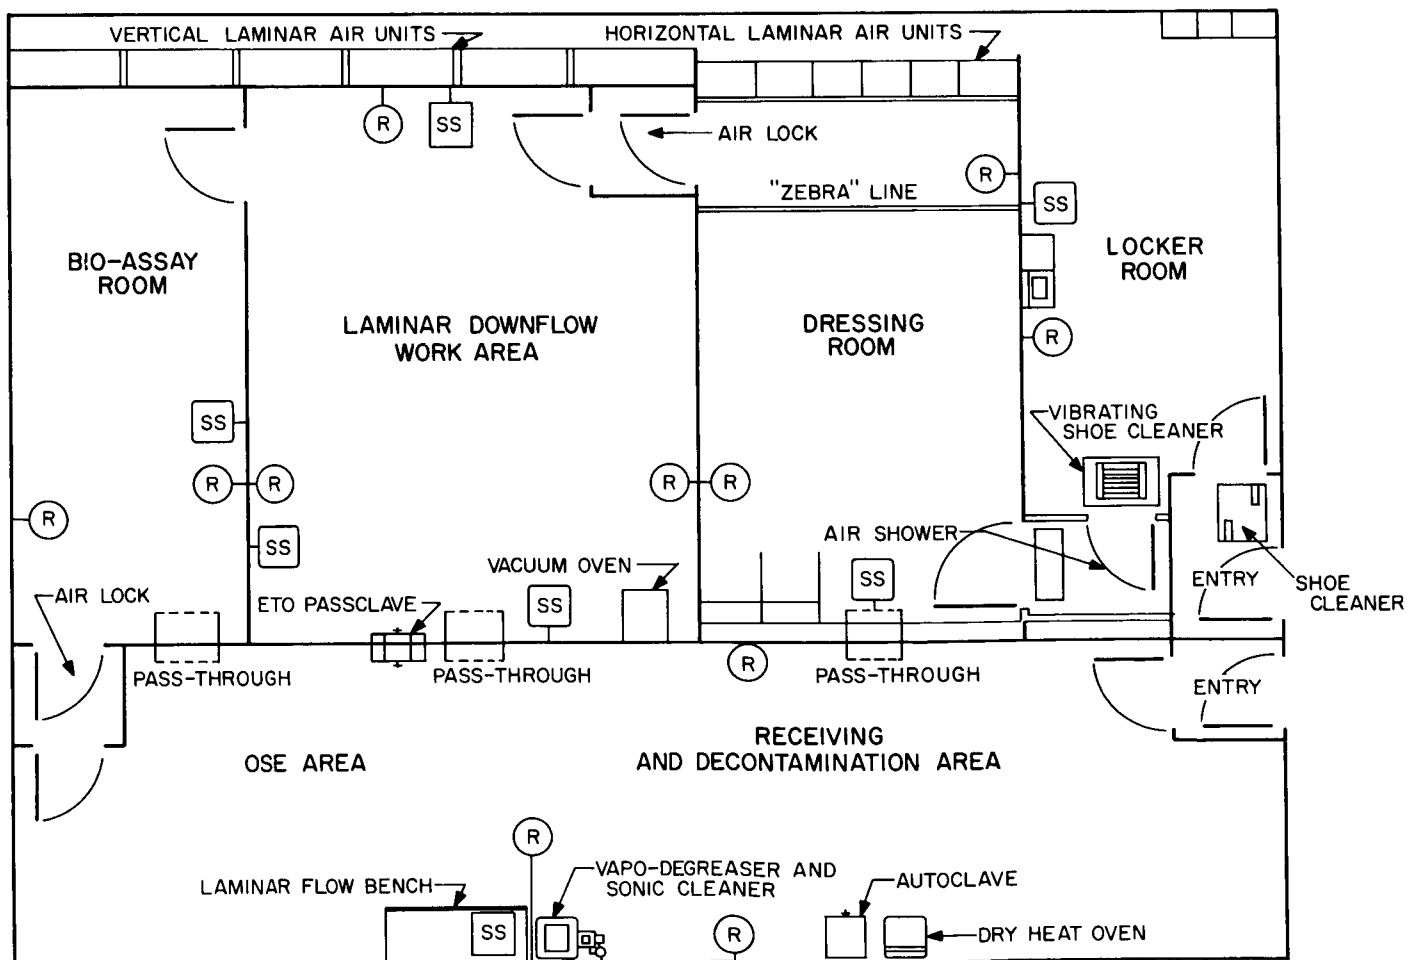
Fig. 8. Locations of microbiological sampling sites in the EASL; Reyniers slit samplers at location R, and trays containing microbial fallout sampling strips at location SS

An aluminum-foil-wrapped tray was placed at each of the microbial fallout sampling sites shown in Fig. 8. At each site, the aluminum foil was carefully removed from the tray, and if necessary, the sterile stainless-steel strips were rearranged as a monolayer with sterile forceps. Trays were placed at work height, i.e., on a level comparable to the height at which hardware was being assembled.

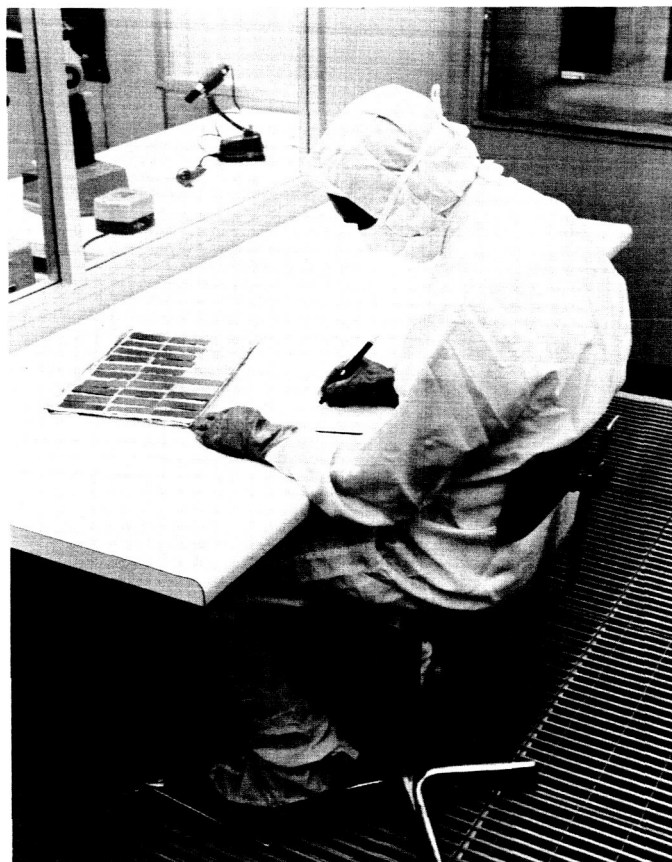
Fig. 9. Bio-assay station; bio-assay room

The visual-assay inspector was on duty inside the hardware assembly area during each period of work (Fig. 9). He documented the personnel hygiene, dressing routine, and operating activities of the people working in the EASL. However, his main function was to observe for breaks in technique (worker using punctured rubber glove, worker dropping tool or part, etc.) or microbial accidents (inadvertent touching of sterile item with contaminated object, sneezing, etc.). When situations such as those described above did occur, the visual-assay inspector provided technical advice and collected microbiological samples if needed. The role of visual-assay inspector was developed considerably during Phase I. This portion is a new approach to the sterilization effort and provides an interface between microbiology and quality assurance. The duties of this person overlap both

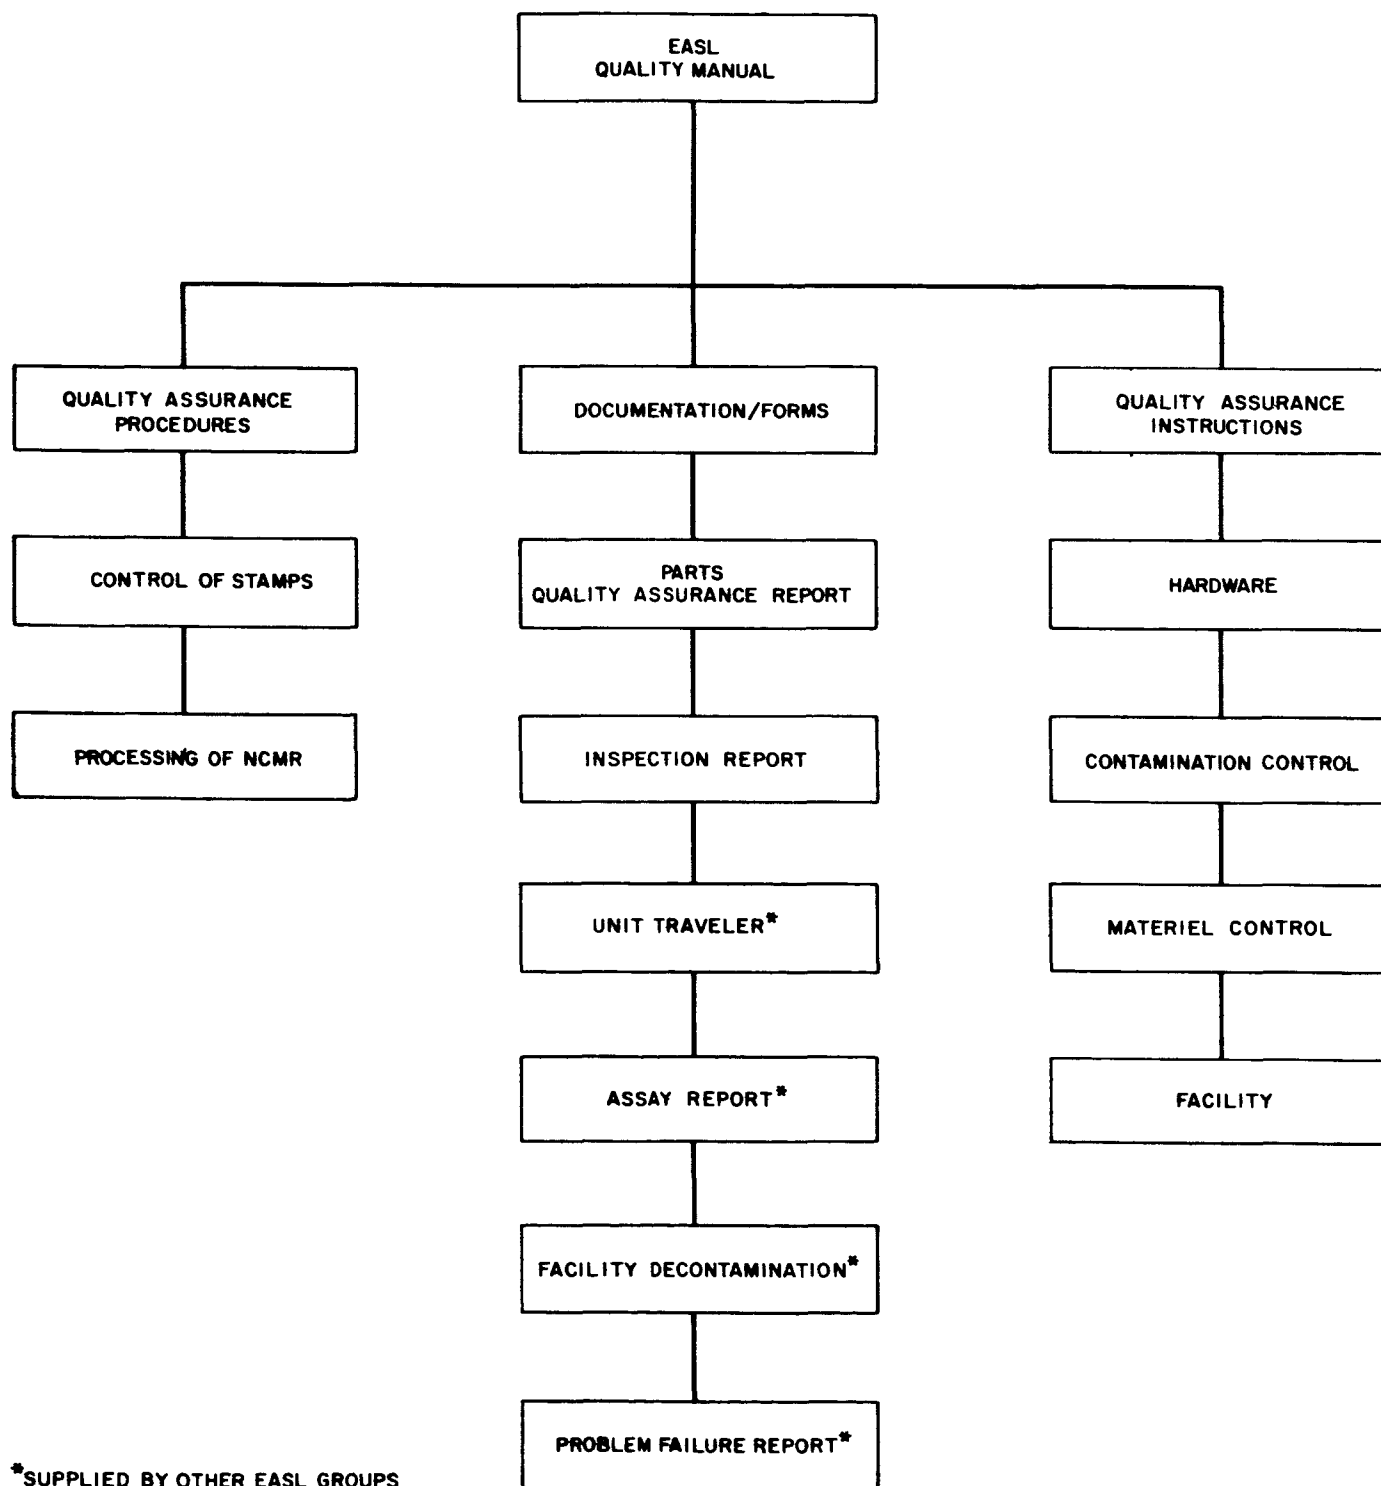
Fig. 10. Quality-assurance specification chart

The QA specification chart is shown in Fig. 10. The documents used by QA to control the flow of the hardware consisted of the following:

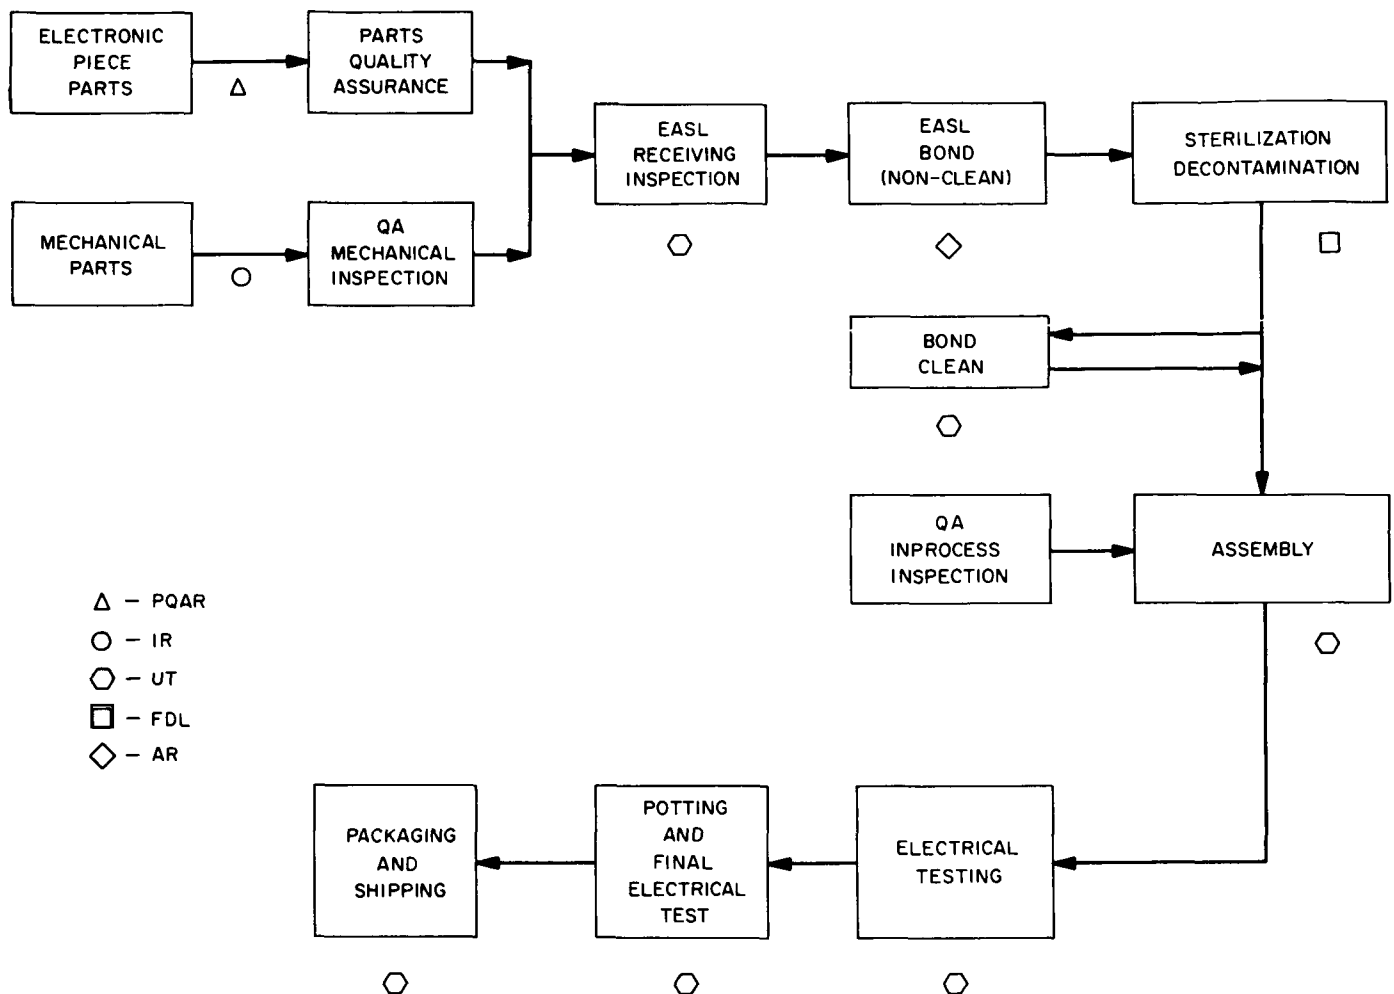
Fig. 11. Typical hardware flow-plan EASL project

Figure 11 is a typical flow plan of hardware assembled in the EASL. No provision is made in the plan for rejected hardware. All discrepant items were documented and disposition made with NCMR (d).<sup>1</sup> The disposition could be "to scrap," "to rework," or "to accept as is." If a particular item was accepted, the traveler was stamped by the QA inspector.

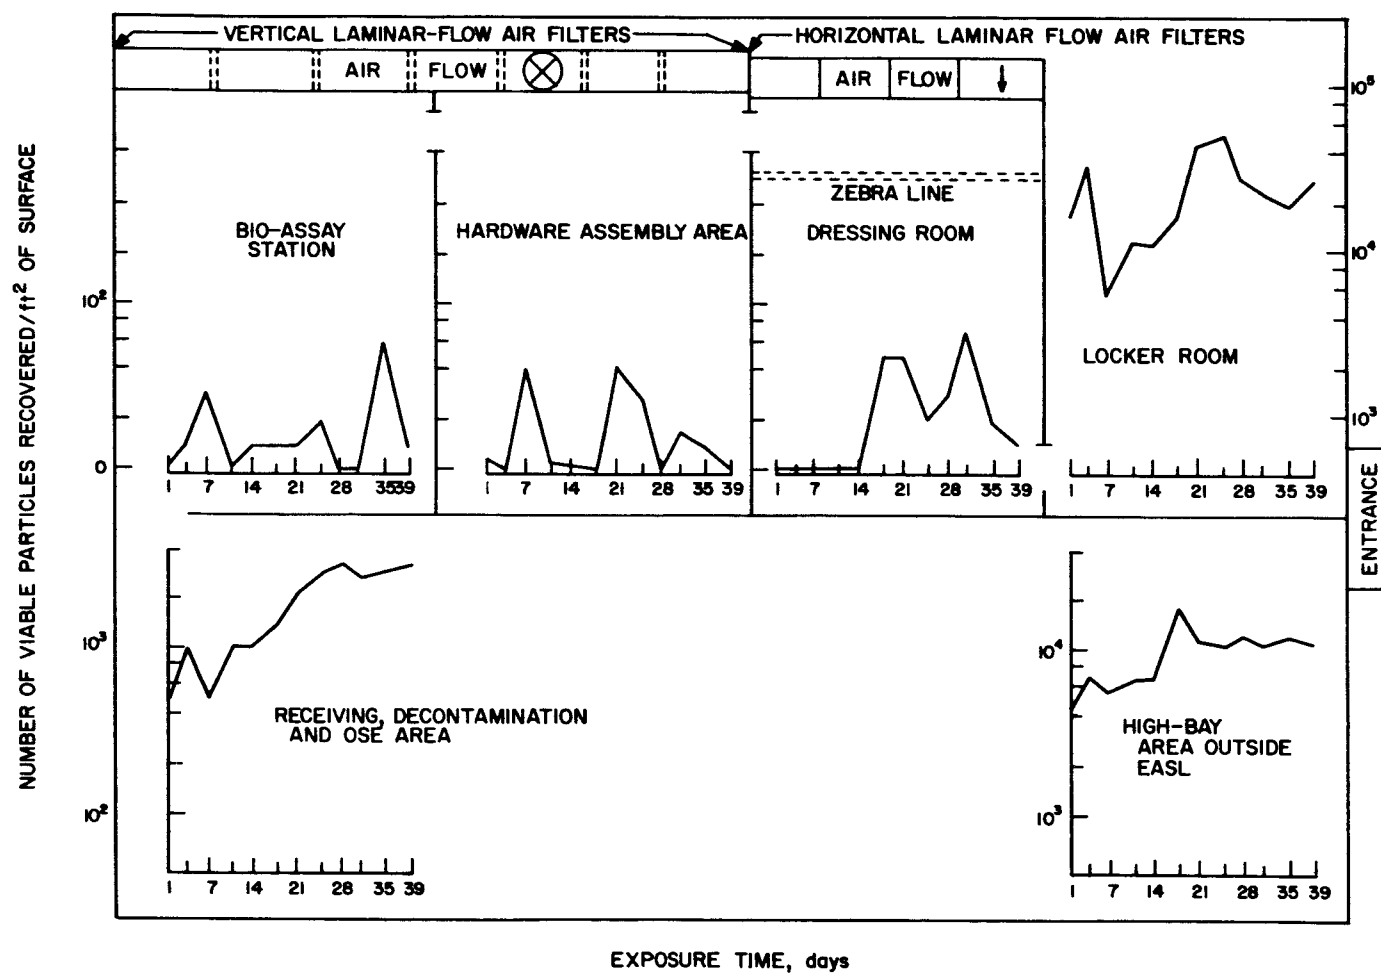
Fig. 12. Results of microbial fallout sampling studies conducted in the EASL

**c. Level of microbial contamination on surfaces.** A summary of the microbial fallout studies is presented in Fig. 12. A rise in the level of microbial contamination on surfaces occurred in the vertical laminar air-flow rooms on the 7th day of exposure of stainless-steel surfaces. During this period, heavy rains resulted in the flooding of the floor in Bldg. 233. Workmen entered the area to affect repairs. Several workmen were not clothed according to the EASL clothing regulations, and these improperly clothed people probably caused the transient rise in surface contamination. Other unexplained rises in contamination occurred in these rooms, but the level of contamination was around 40 microorganisms per ft<sup>2</sup> of surface, considerably below the acceptable level of 200 ft<sup>2</sup> (Ref. 1). Microbial contamination on surfaces

outside of the vertical laminar air-flow rooms was considerably higher (up to 50,000 microorganisms per ft<sup>2</sup> in the locker room), ranging from two to three orders of magnitude higher than levels within the bio-assay station and the hardware assembly area. These data indicate that the strip method of sampling microbial contamination on surfaces is reliable and fairly sensitive.
